NASA TN D-6988

EFFECT OF AGING AT 1040° C (1900° F)
ON THE DUCTILITY AND STRUCTURE
OF A TANTALUM ALLOY, T-111

by Gordon K. Watson and Joseph R. Stephens

Lewis Research Center

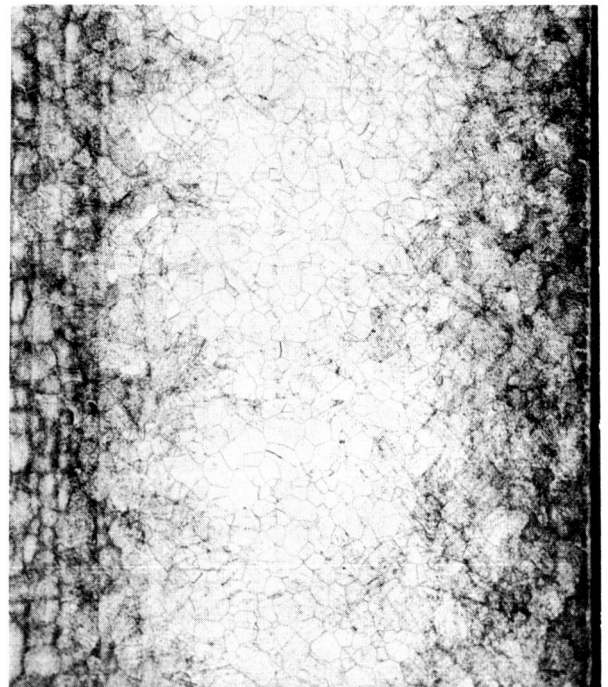
General metallography. - The microstructures of T-111 tubing samples in the as-received condition and after aging for 1128 and 2862 hours in vacuum at 1040°C (1900°F) are compared in figure 6. The as-received tubing is characterized by an equiaxed grain structure with no visible precipitates at this low magnification (X100). In contrast, 1040°C (1900°F) aging of the T-111 tubing produced dark bands of precipitate particles near the outside and inside surfaces (figs. 6(b) and (c)). No differences could be seen between the inside and outside surfaces of the tubing. The amount of precipitate particles observed after aging for 1128 and 2862 hours appears to be about the same for both conditions, which suggests that most of the precipitates were formed in less than about 1100 hours.

(a) As-received.

(b) Aged 1128 hours.

(c) Aged 2862 hours.

Figure 6. - Effect of aging at 1040°C (1900°F) in vacuum on microstructure of T-111 tubing. Longitudinal section; etchant, hydrofluoric acid, nitric acid, glycerine. X100.

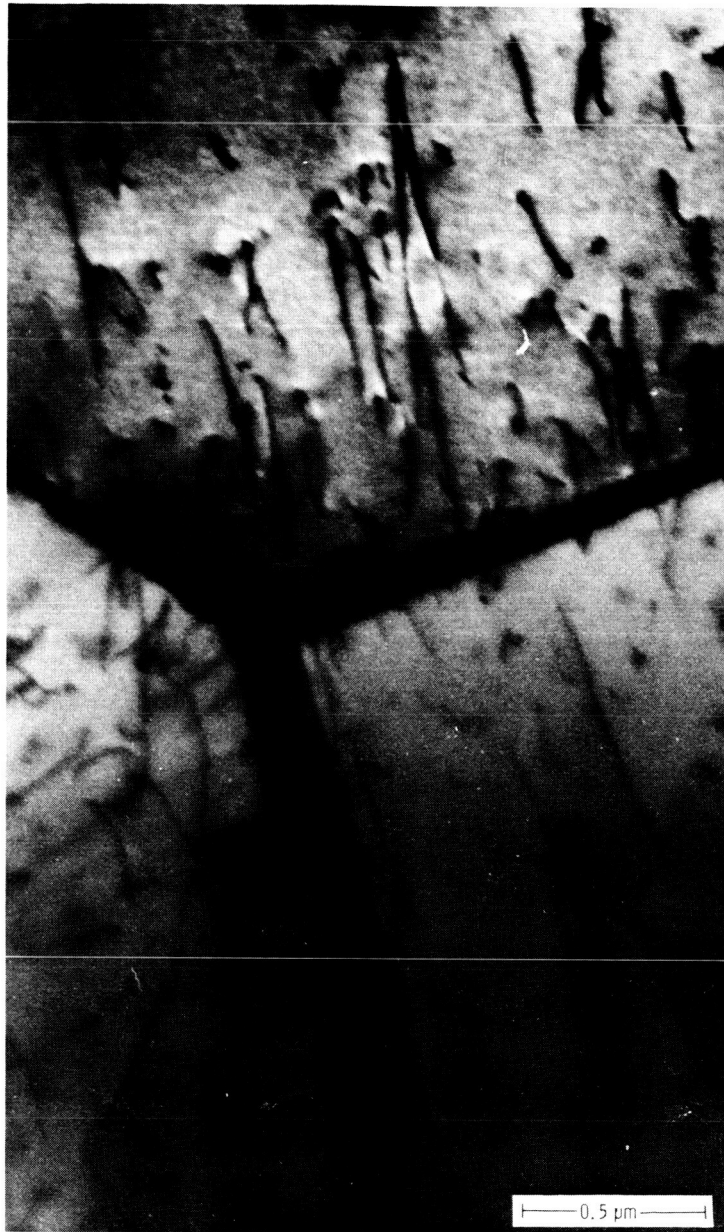
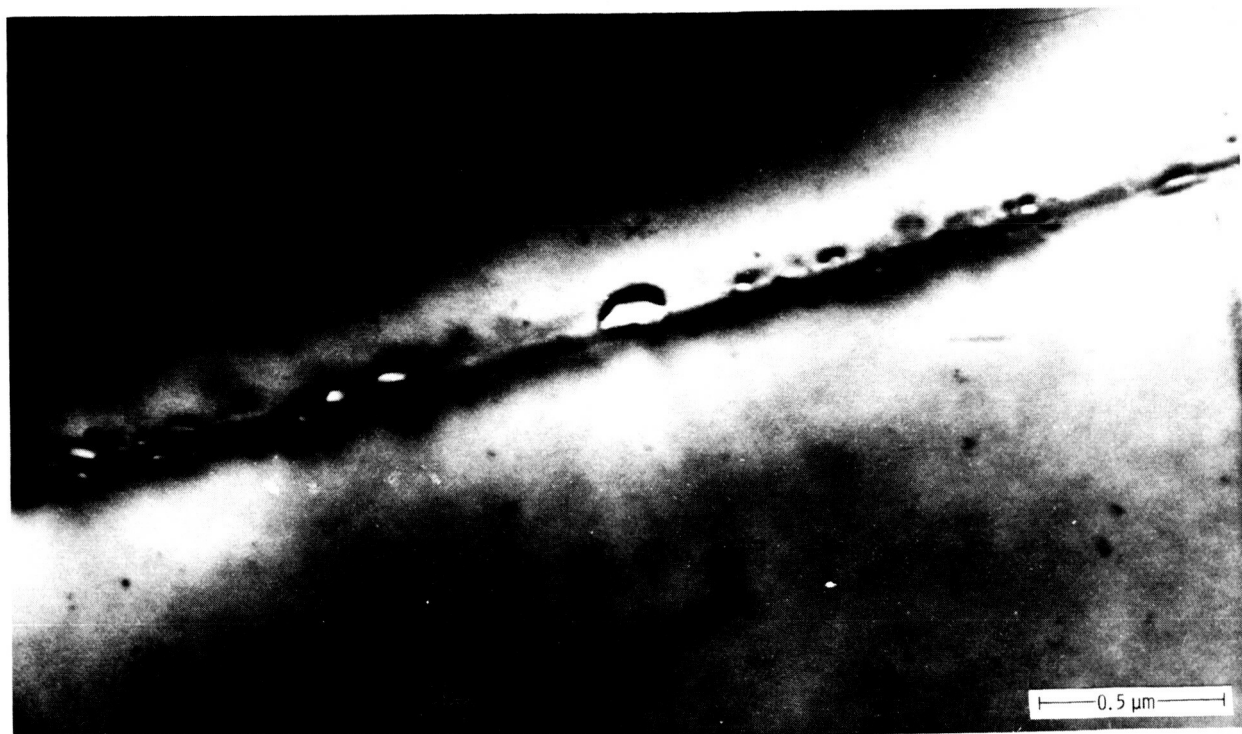
(a) As-received.

Figure 9. - Transmission electron micrographs of as-received and aged T-111 sheet.

(b) Aged 1000 hours at 980°C (1800°F) in vacuum.

(c) Aged 1000 hours at 980°C (1800°F) in lithium.

(d) Aged 1000 hours at 980°C (1800°F) and 4000 hours at 1040°C (1900°F) in vacuum.

(e) Aged 1000 hours at 980°C (1800°F) and 4000 hours at 1040°C (1900°F) in lithium.

(f) Aged 1000 hours at 1315⁰ C (2400⁰ F) in vacuum.

(g) Aged 1000 hours at 1315⁰ C (2400⁰ F) in lithium.

Transmission electron microscopy also was used to examine sheet T-111. Figure 9(a) shows that the as-received material had numerous dislocations but was free of precipitates. This foil was prepared from a disk cut from a bend test specimen, which accounts for the high dislocation density observed. Figures 9(b) and (c) shows that aging at 980° C (1800° F) for 1000 hours resulted in formation of rows of precipitate particles approximately 0.05 micrometers in diameter lying along grain boundaries. Aging these specimens for an additional 4000 hours at 1040° C (1900° F) resulted in fewer and larger particles being present at grain boundaries (figs. 9(d) and (e)). This suggests agglomeration of particles with extended aging time. The average particle size was approximately 0.3 micrometer after the extended aging treatment. Transmission electron microscopy observations on T-111 sheet aged for 1000 hours at 1315° C (2400° F) failed to reveal any precipitate particles (figs. 9(f) and (g)), confirming the light microscope observations that precipitation of grain boundary particles did not occur in T-111 during aging for several thousand hours at 1315° C (2400° F).

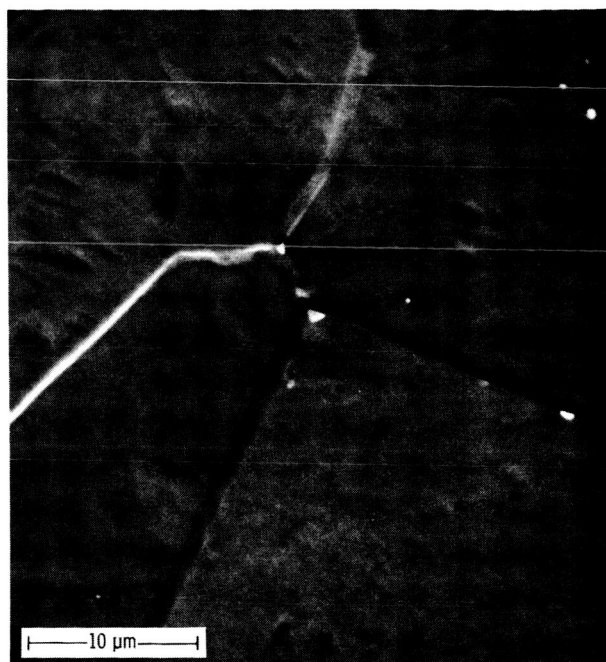
(a) 10 000 hours at 1040° C (1900° F).

(b) 10 000 hours at 1200° C (2200° F).

Figure 10. - Scanning electron micrographs of aged T-111 tubing. Etchant, ammonium bifluoride, nitric acid, and water. X2500.

Scanning electron microscopy was used to observe particle morphology and distribution in T-111 tubing. Specimens were cut from tubing that had operated for 10 000 hours with potassium flowing through the tube while the outside diameter was exposed to a vacuum environment (ref. 4). Specimens cut from portions of the tubing that operated at 1040° C (1900° F) and 1200° C (2200° F) were prepared metallographically. Figure 10(a) shows the microstructure of the 1040° C (1900° F) portion of the tubing where numerous particles approximately 0.5 to 0.8 micrometer in diameter are noted to line the grain boundaries. A comparison of this particle size with particle sizes observed in aged T-111 sheet (figs. 9(b) and (d)) suggests that particle size continues to increase with increase in aging time at 1040° C (1900° F). A portion of the tubing that operated at 1200° C (2200° F) is shown in figure 10(b) where particles are observed at grain boundary triple points only, suggesting that 1200° C (2200° F) is near the maximum temperature where precipitation during aging occurs in T-111.
